Priming difficult ink feed tubes

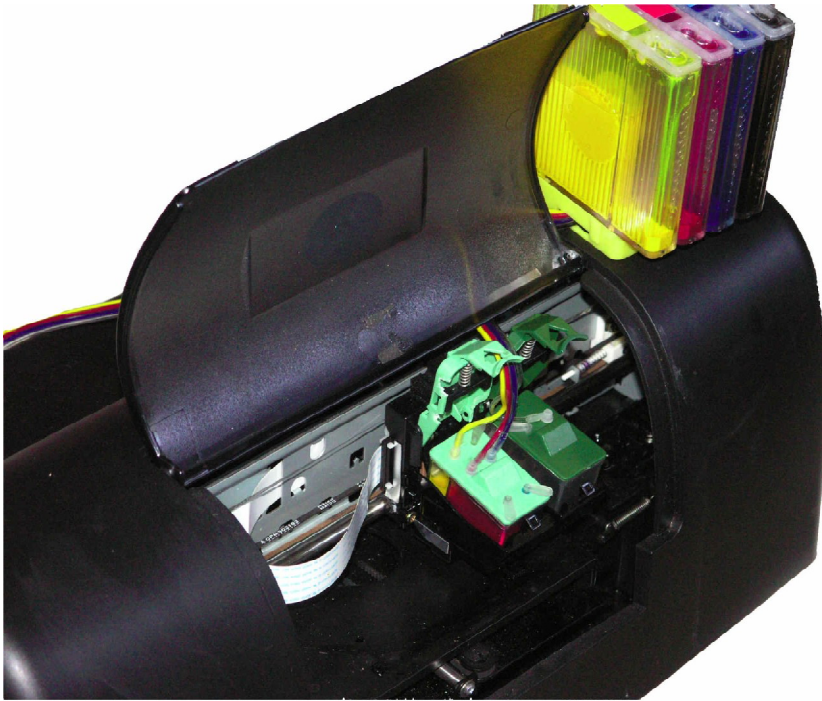
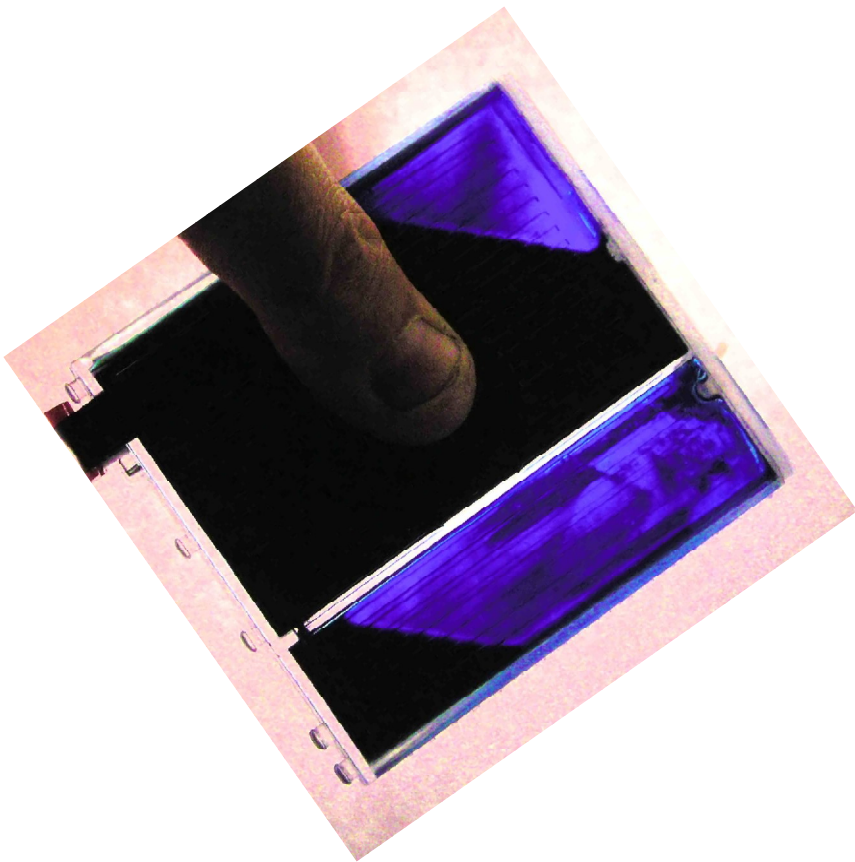
Fluid head pressure of the reservoir feed chamber may be too low to provide sufficient pressure to overcome surface tension of the feed lines. This is solved by increasing fluid pressure slightly. Tilting the chamber as in the image and squeezing slightly the larger chamber area will cause ink to pulse into the smaller chamber. Replace the chamber into the holder base and position as above image to complete prime.
